BASTIÓN DE SAN DIEGO

INTRAMUROS ADMINISTRATION
MINISTRY OF HUMAN SETTLEMENTS

The conservation of Bastión de San Diego began on March 17, 1979. This initial effort to clear the structure of vegetation and waste led to the discovery of interesting architectural features, many of them previously unrecorded and photographed.

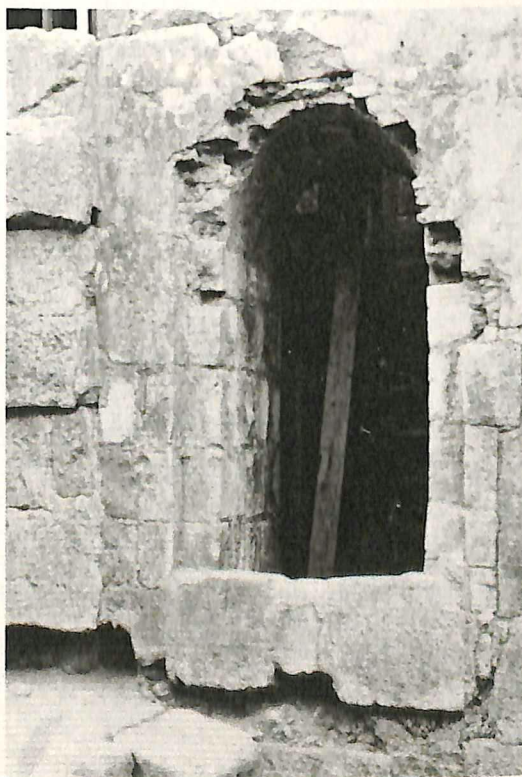
Figure 17. In the original structure, this narrow archway led to the patio. When the outer patio was backfilled with some 1.56 meters of sand, part of this doorway was blocked. Marks on the door frame indicate that it was fitted with a door.

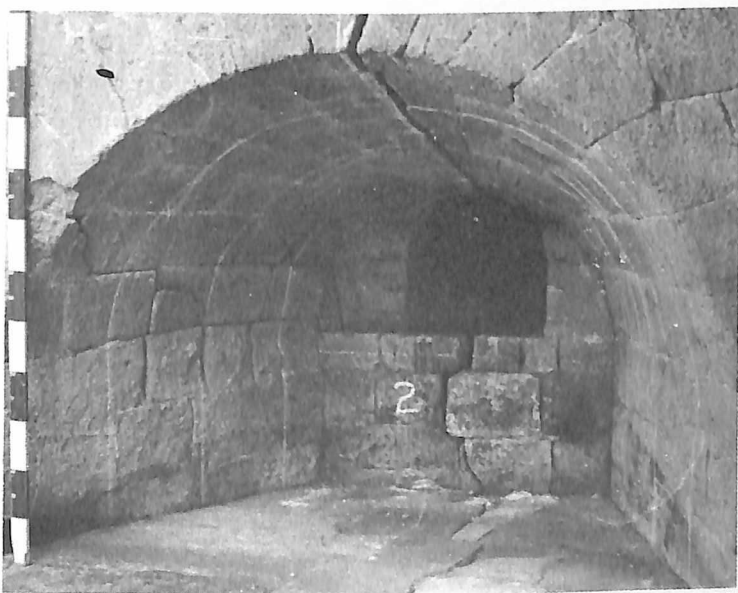
Figure 23. Casemate No. 2 has a deep crack running through its ceiling. It is similar in construction to casemates 1, 3, 7, 8, 9 and 11. They are characterized by a wide opening that narrows down in the interior. All have lookout windows, though most of them are now sealed with adobe. Their floorings are paved and leveled.

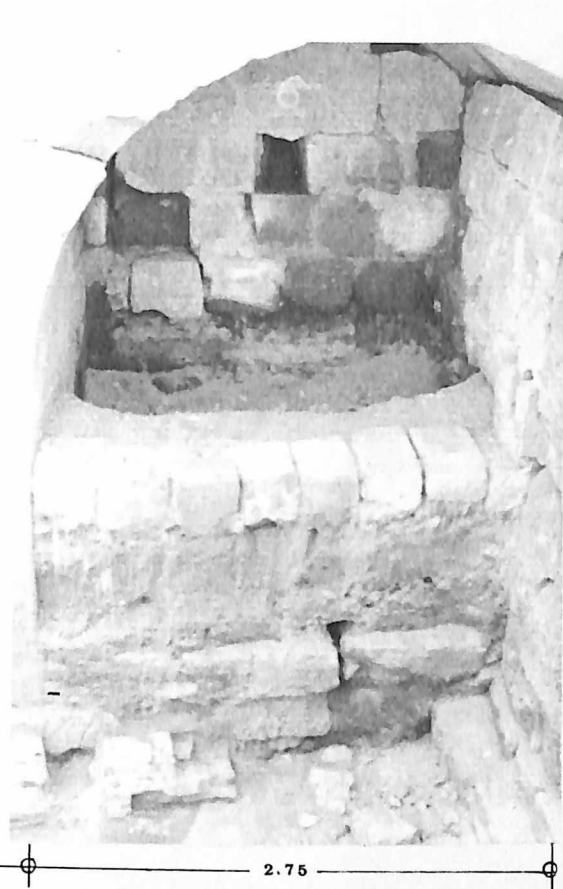
Casemate No. 6 appears in a "disturbed condition." Its opening has been partly sealed by adobe blocks from flooring till midway of the arch. Soil fills its inner cavity, in an attempt, perhaps, to raise the flooring. On the other hand, the flooring of casemate No. 4 follows the style or manner of the newer casemates.

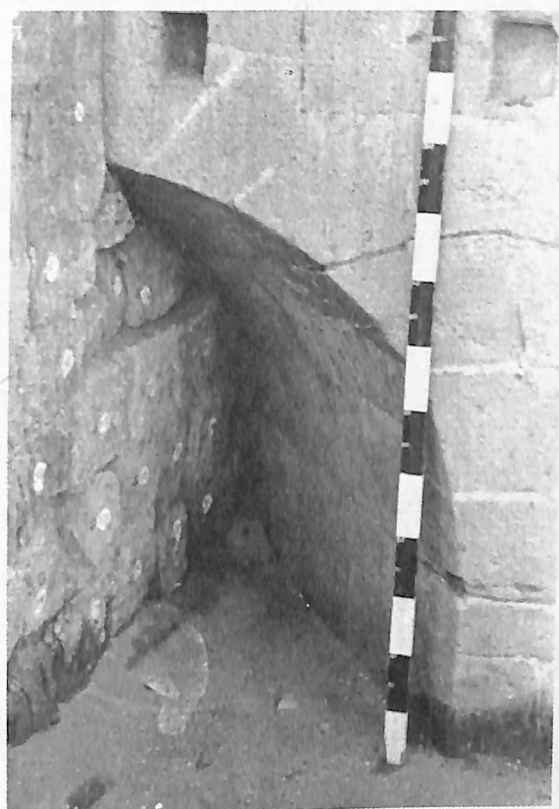
Figure 28. Casemate No. 7 has been totally obstructed by the spoke built right through its center. Like casemate No. 3, grooves on the outer wall by the entrance may be seen.

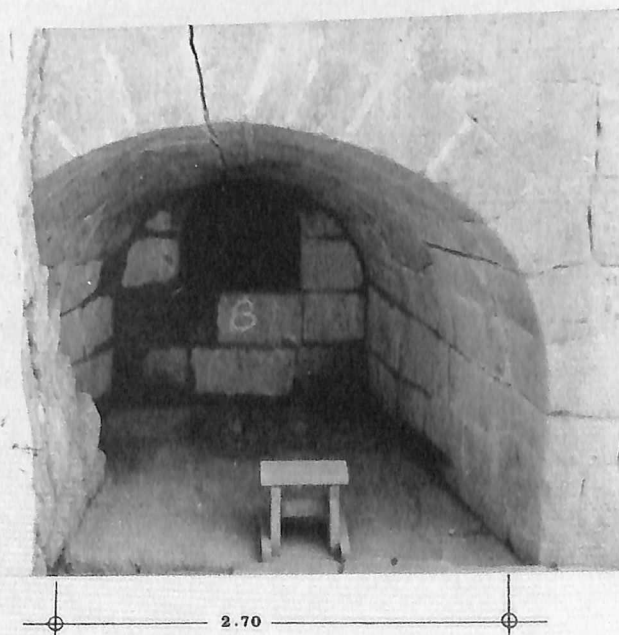
Figure 29. Casemate No. 8 manifests the same deep cleavage that has marred its otherwise perfect condition. The wall of one of the spokes partly encroaches on its opening.

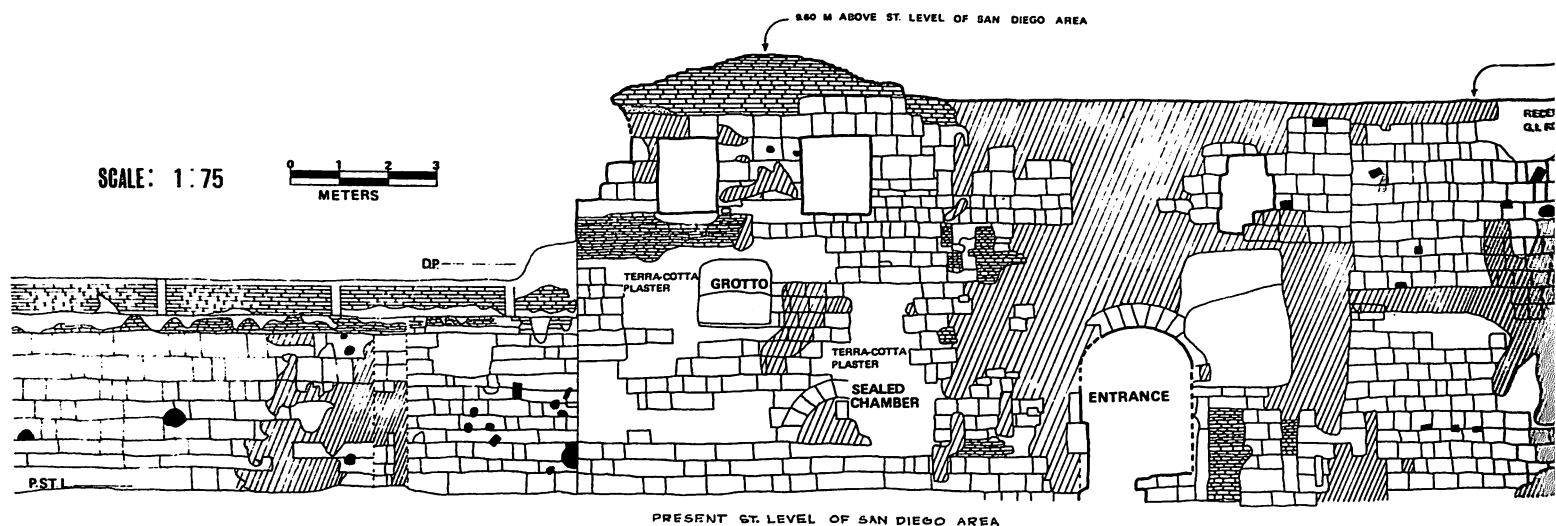
Figure 44. This documentation of Bastión de San Diego shows its actual state at the start of the restoration program in 1979.

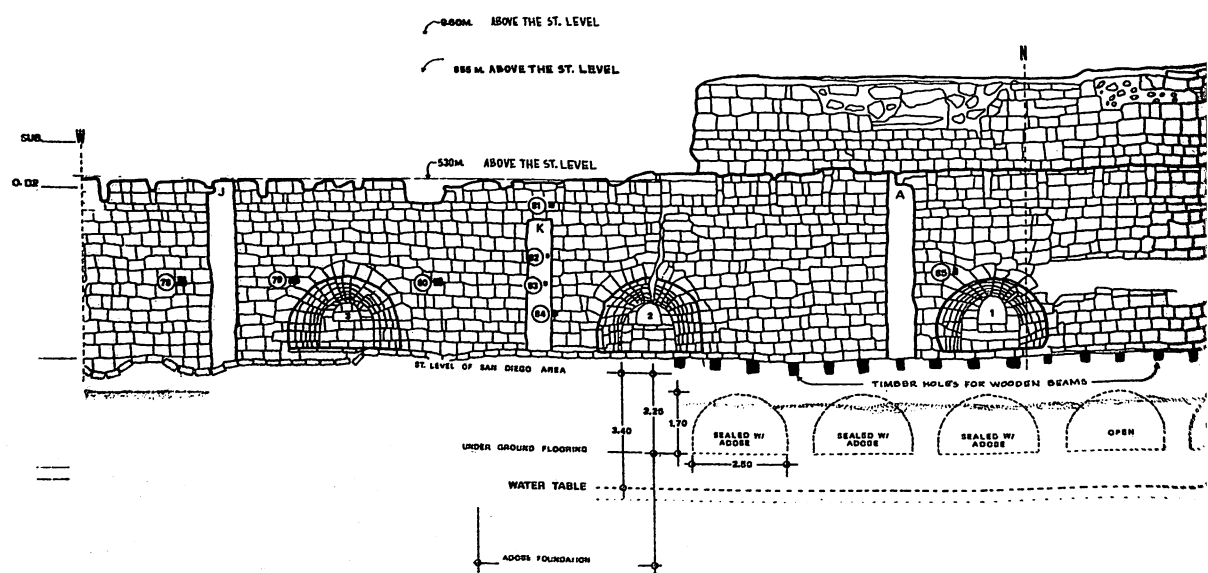
Figure 45, A and B. The documentation of the interior portion of the third circular structure showing the condition of the walls and casemates and the position of the buried chambers below the street level.

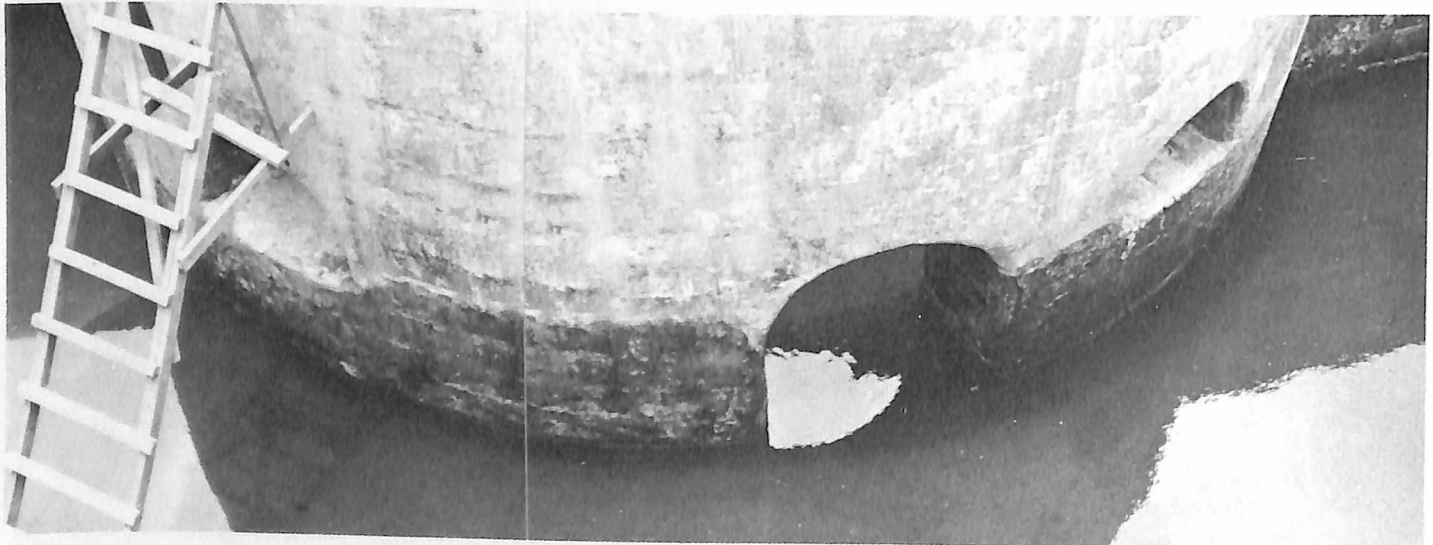
Figure 55. The exterior wall of the first circle showing the water mark indicating how high the water rises.

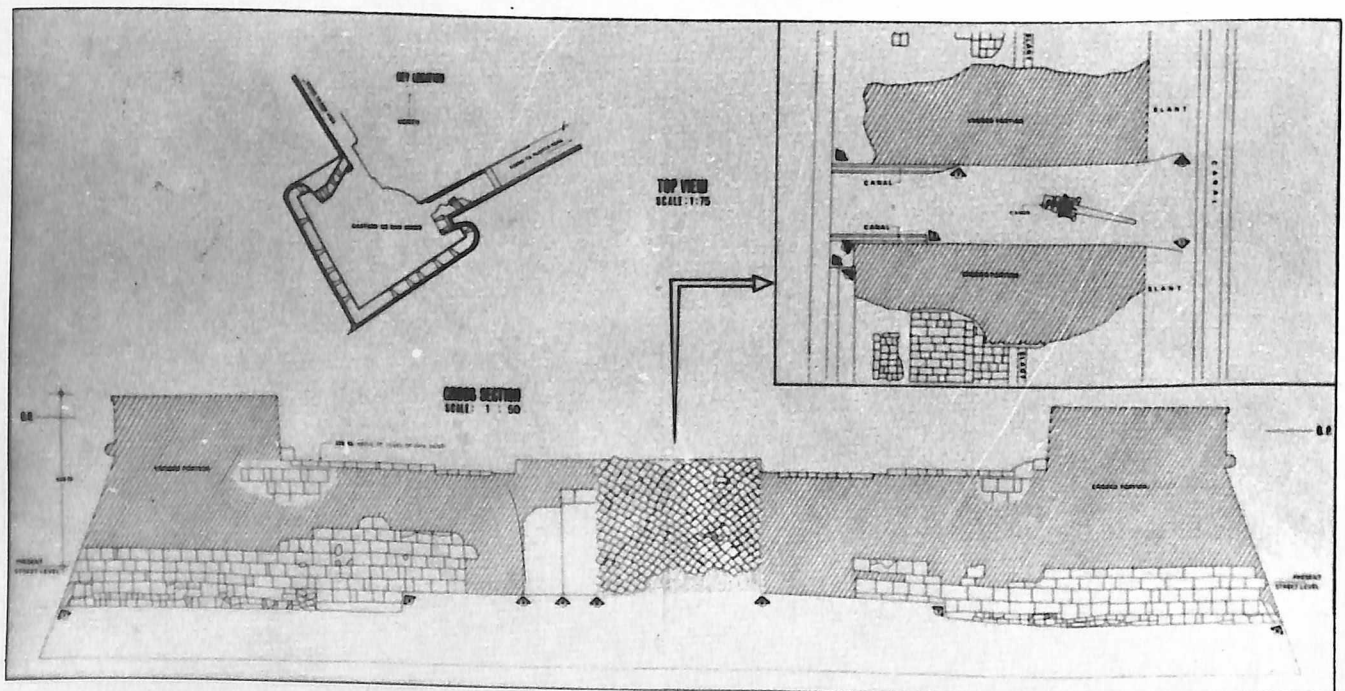
Photograph shows the condition of the west flank. The central portion of the drawing shows how mojonas—landmarks—were used to shore up eroding portion of the wall.

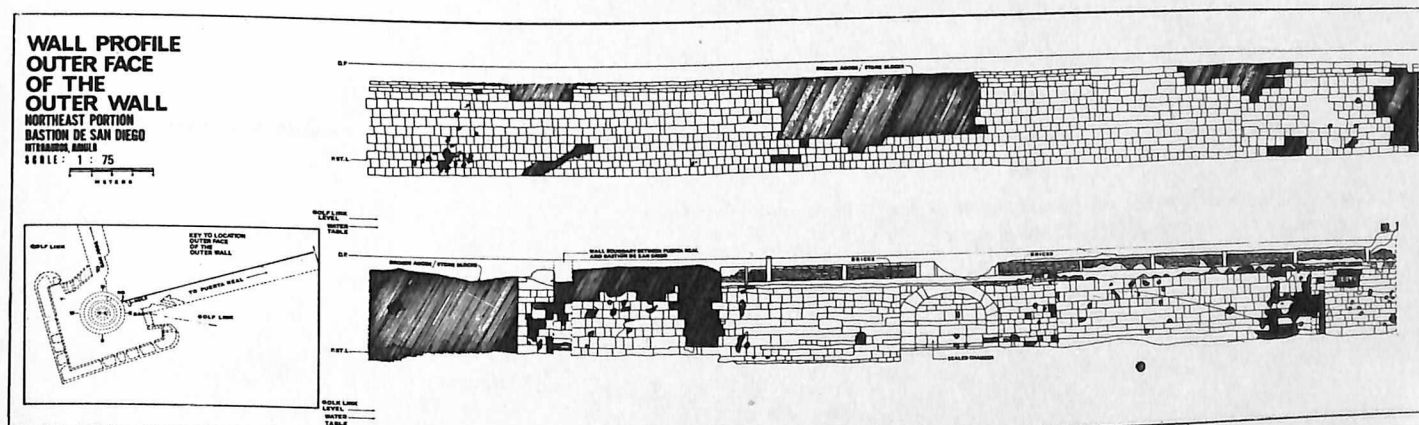
The condition of the wall on the northeast portion of Bastión de San Diego facing Muralla Street.

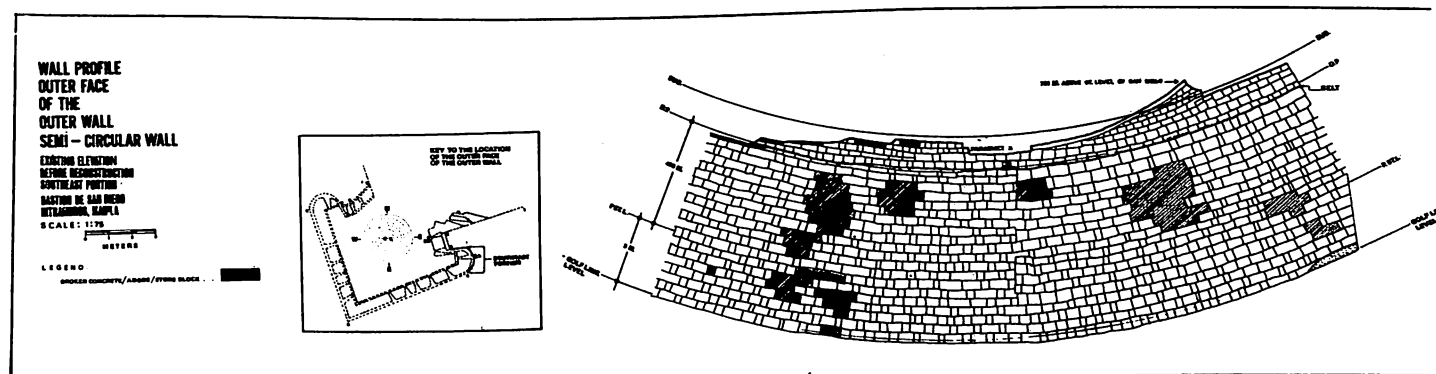
The condition of the eastern orillon and its elevation before reconstruction.

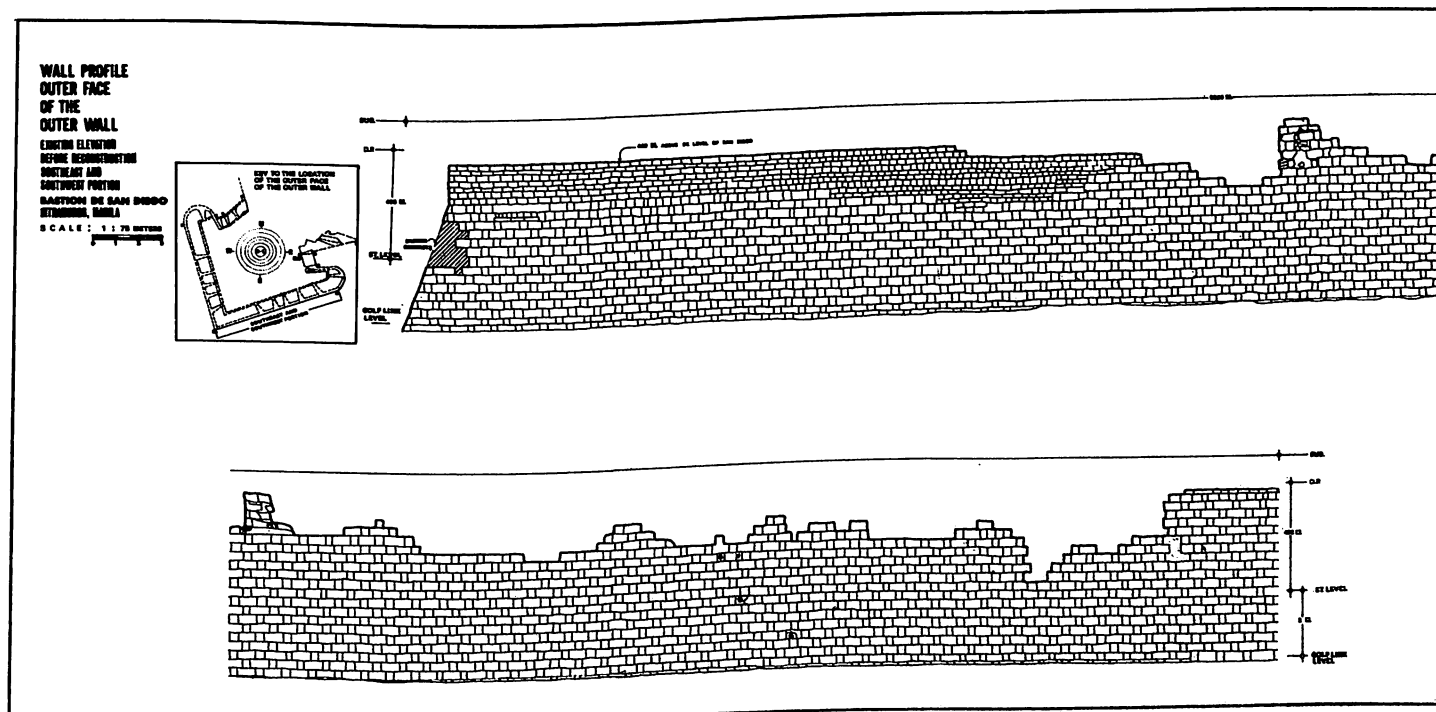
The existing elevation and status of the wall before reconstruction of the southeast and southwest portions.
